## EXTERIOR

## 01 / EXTERIOR / WOODWARD VIEW

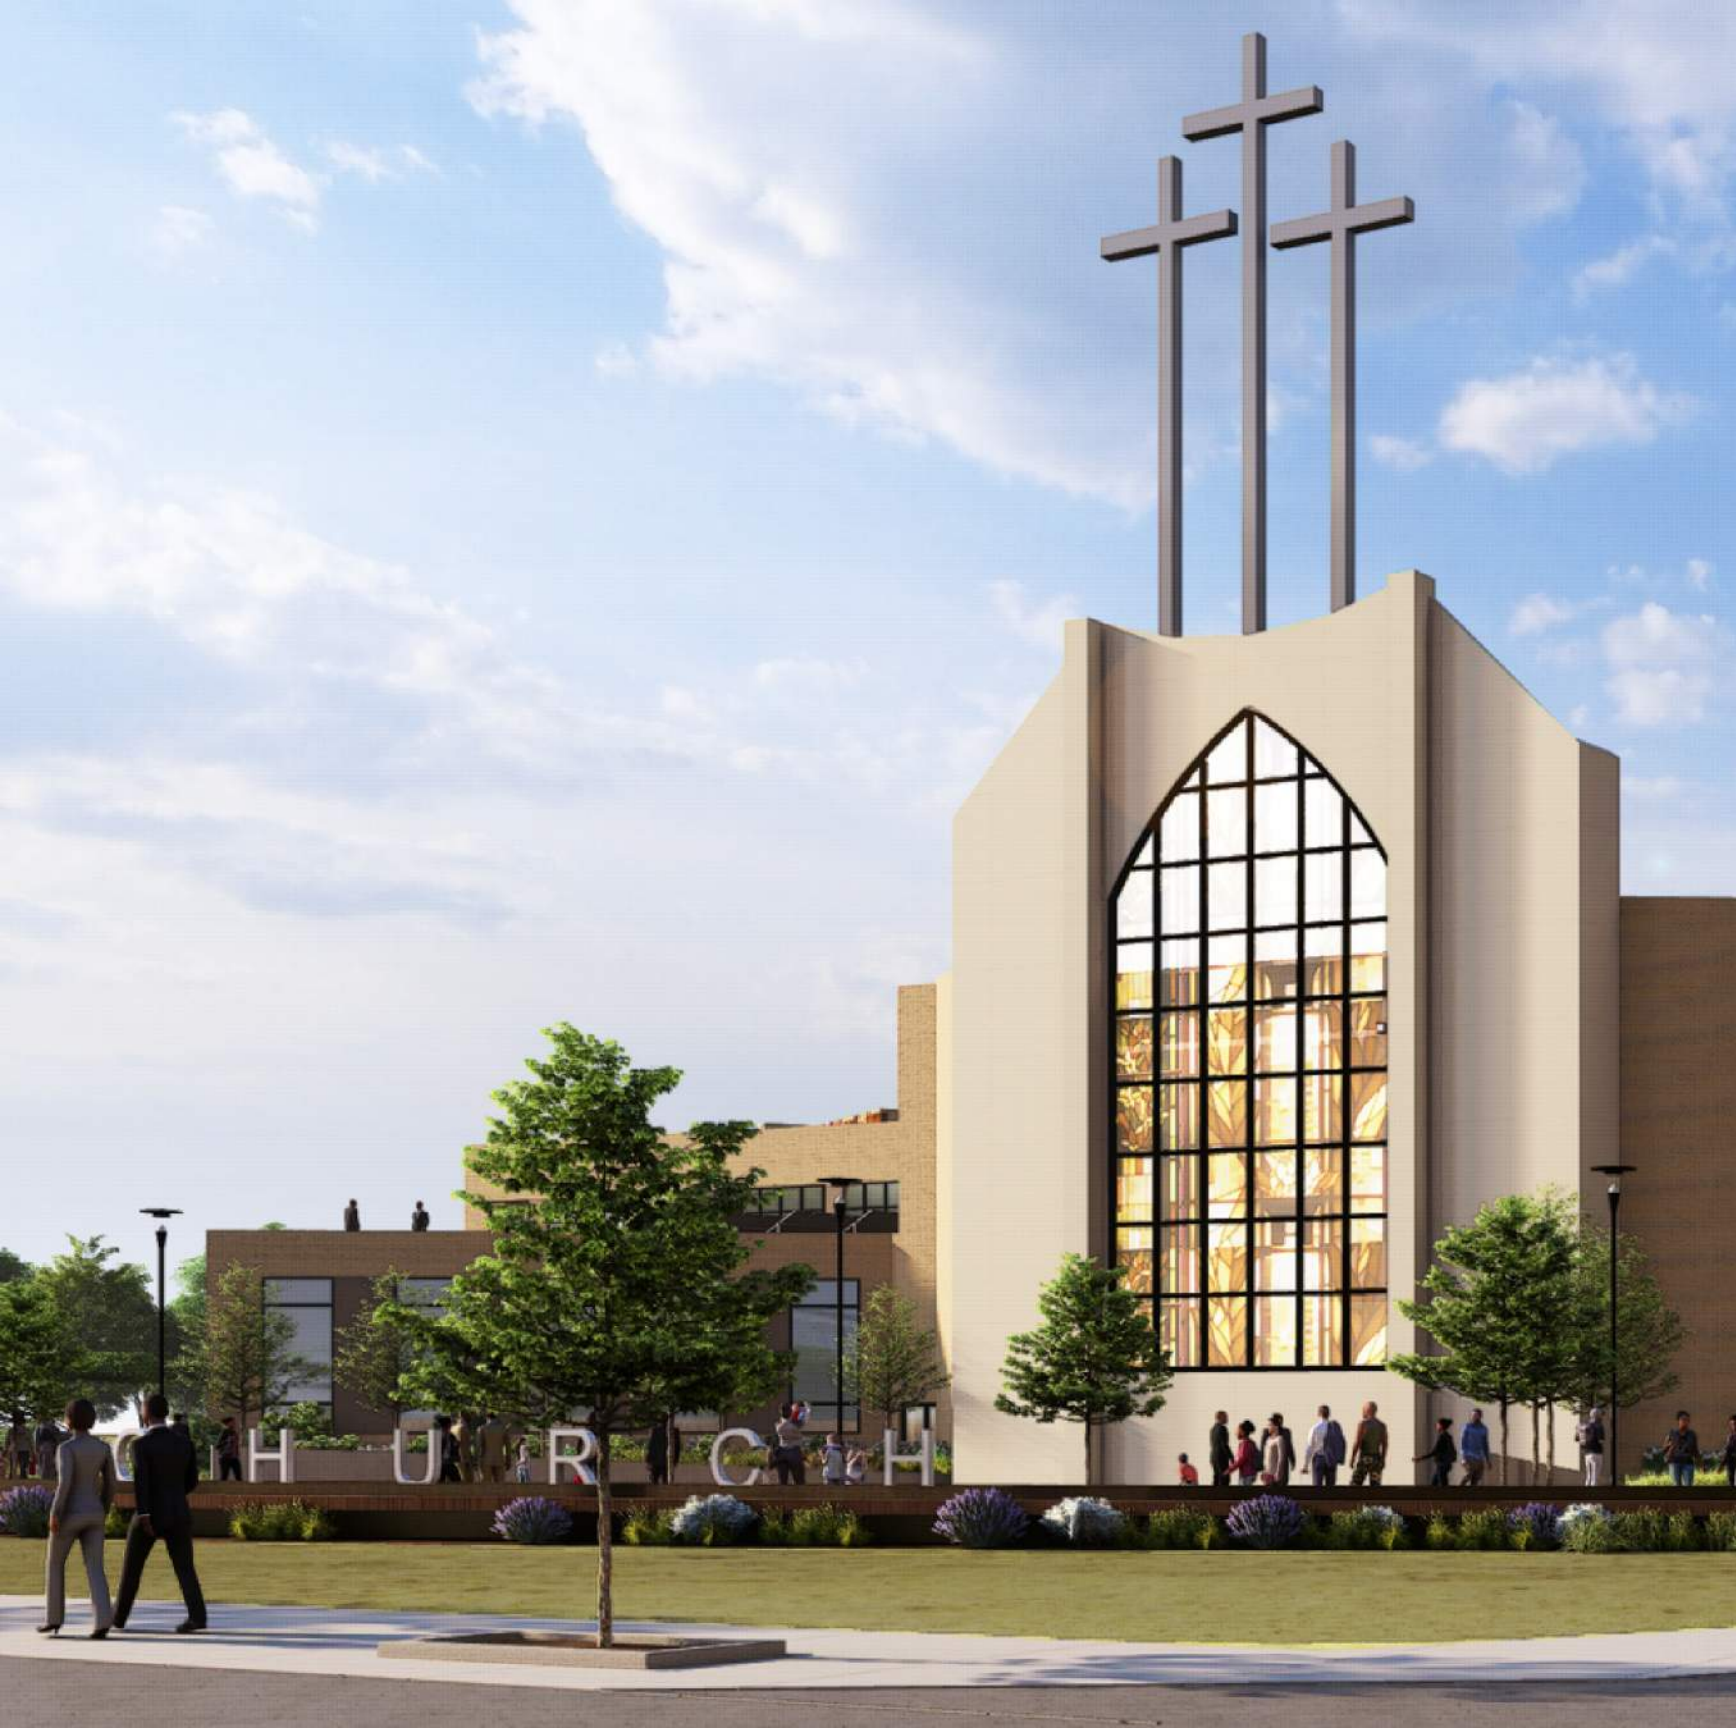
01 / EXTERIOR / WOODWARD VIEW

- 1 INDIVIDUAL STANDING LETTERS ON BRICK BASE (GROUND ILLUMINATE SIGNAGE)
- 2 CLAD EXISTING BRICK FACADE WITH PRECAST RAINSCREEN
- 3 ADD CROSSES TO TOP
- 4 STAINED GLASS-LOOK ON EXISTING STOREFRONT
- 5 EXISTING WINDOW OPENINGS
- 6 EXISTING BRICK WALL WITH PAINTED ART MURAL

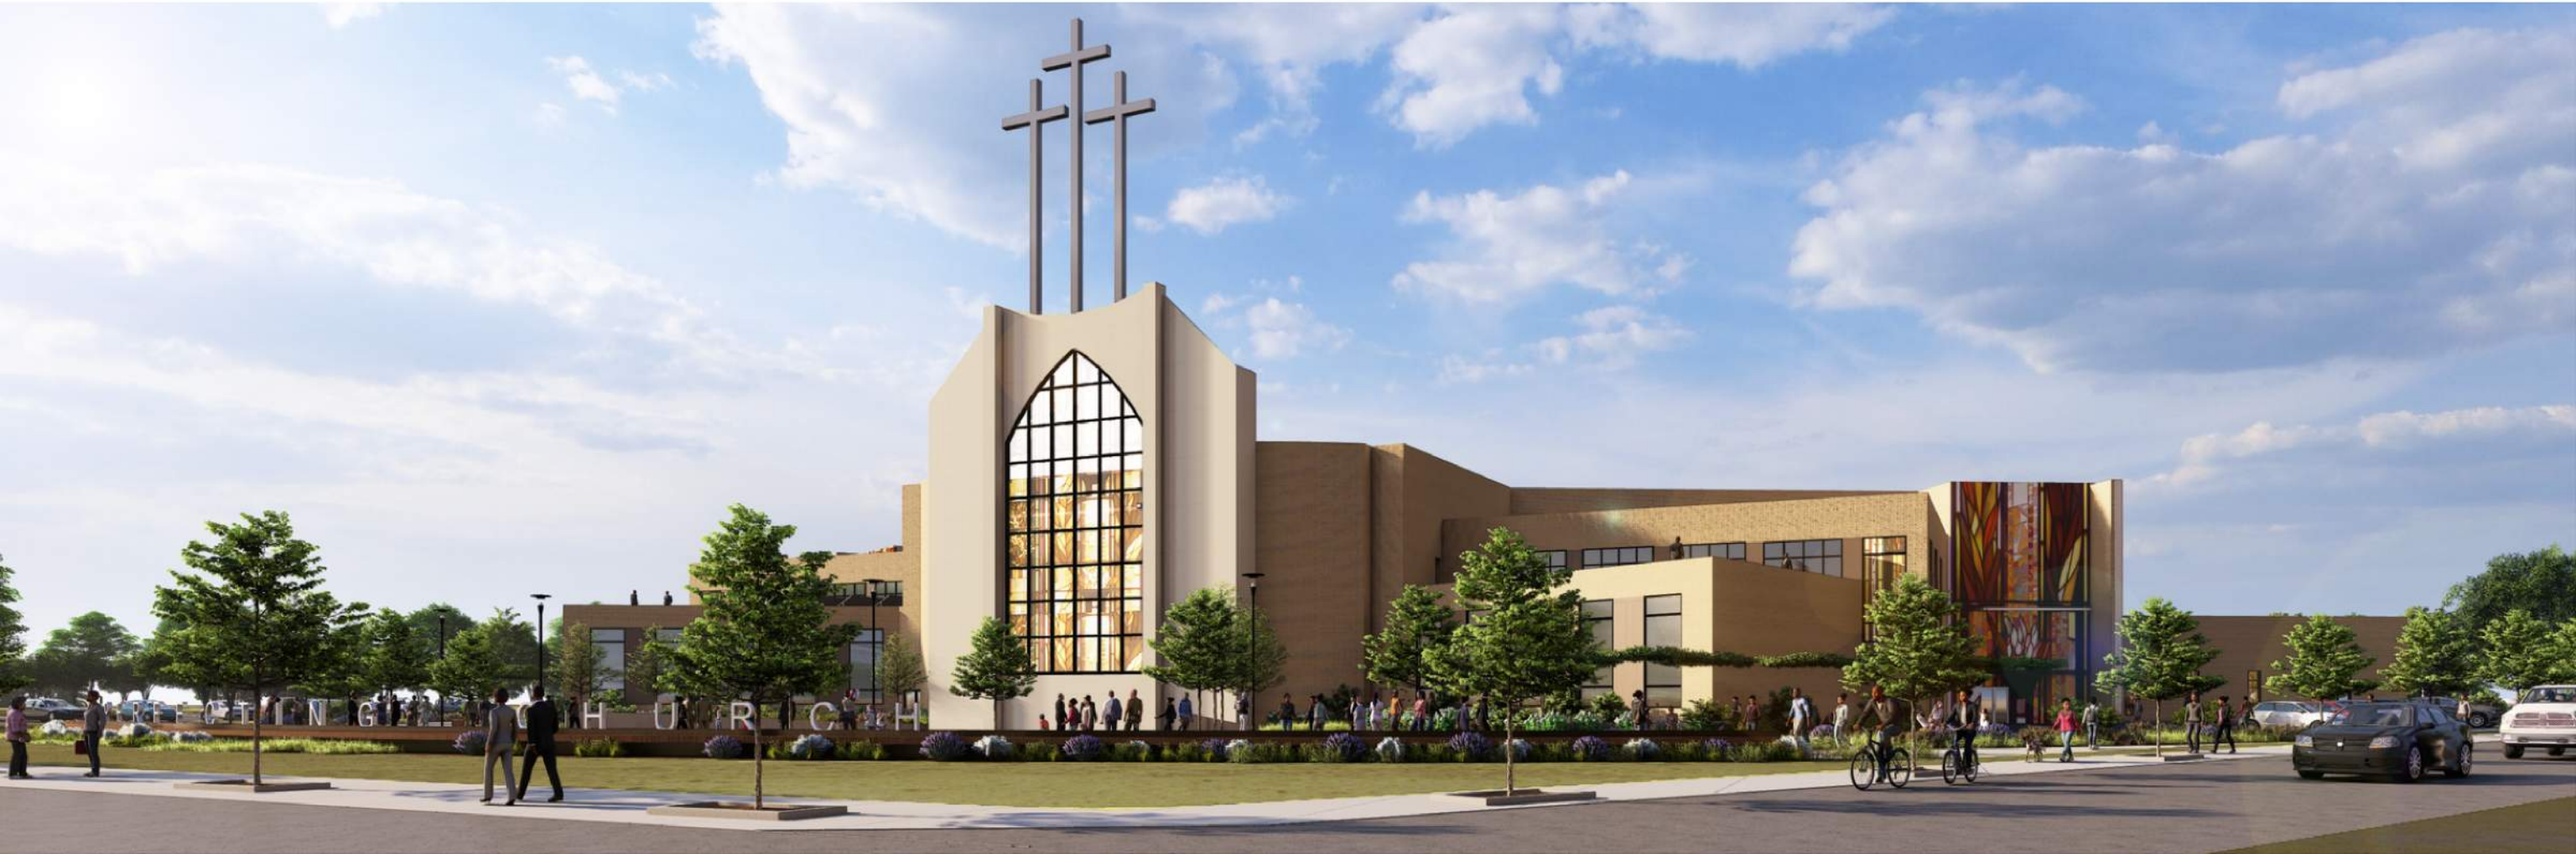
01 / EXTERIOR / NORTH ENTRY

1 COMPOSITE METAL LOUVER SYSTEM ON EXISTING BRICK

2 PORCELAIN EXTERIOR WALL TILE RAINSCREEN SYSTEM. MATTE FINISH

3 PORCELAIN EXTERIOR WALL TILE RAINSCREEN SYSTEM. POLISHED FINISH

4 COMPOSITE METAL PANEL CROSS.

5 15'H COMPOSITE METAL PANEL VESTIBULE

6 EXISTING BRICK FACADE

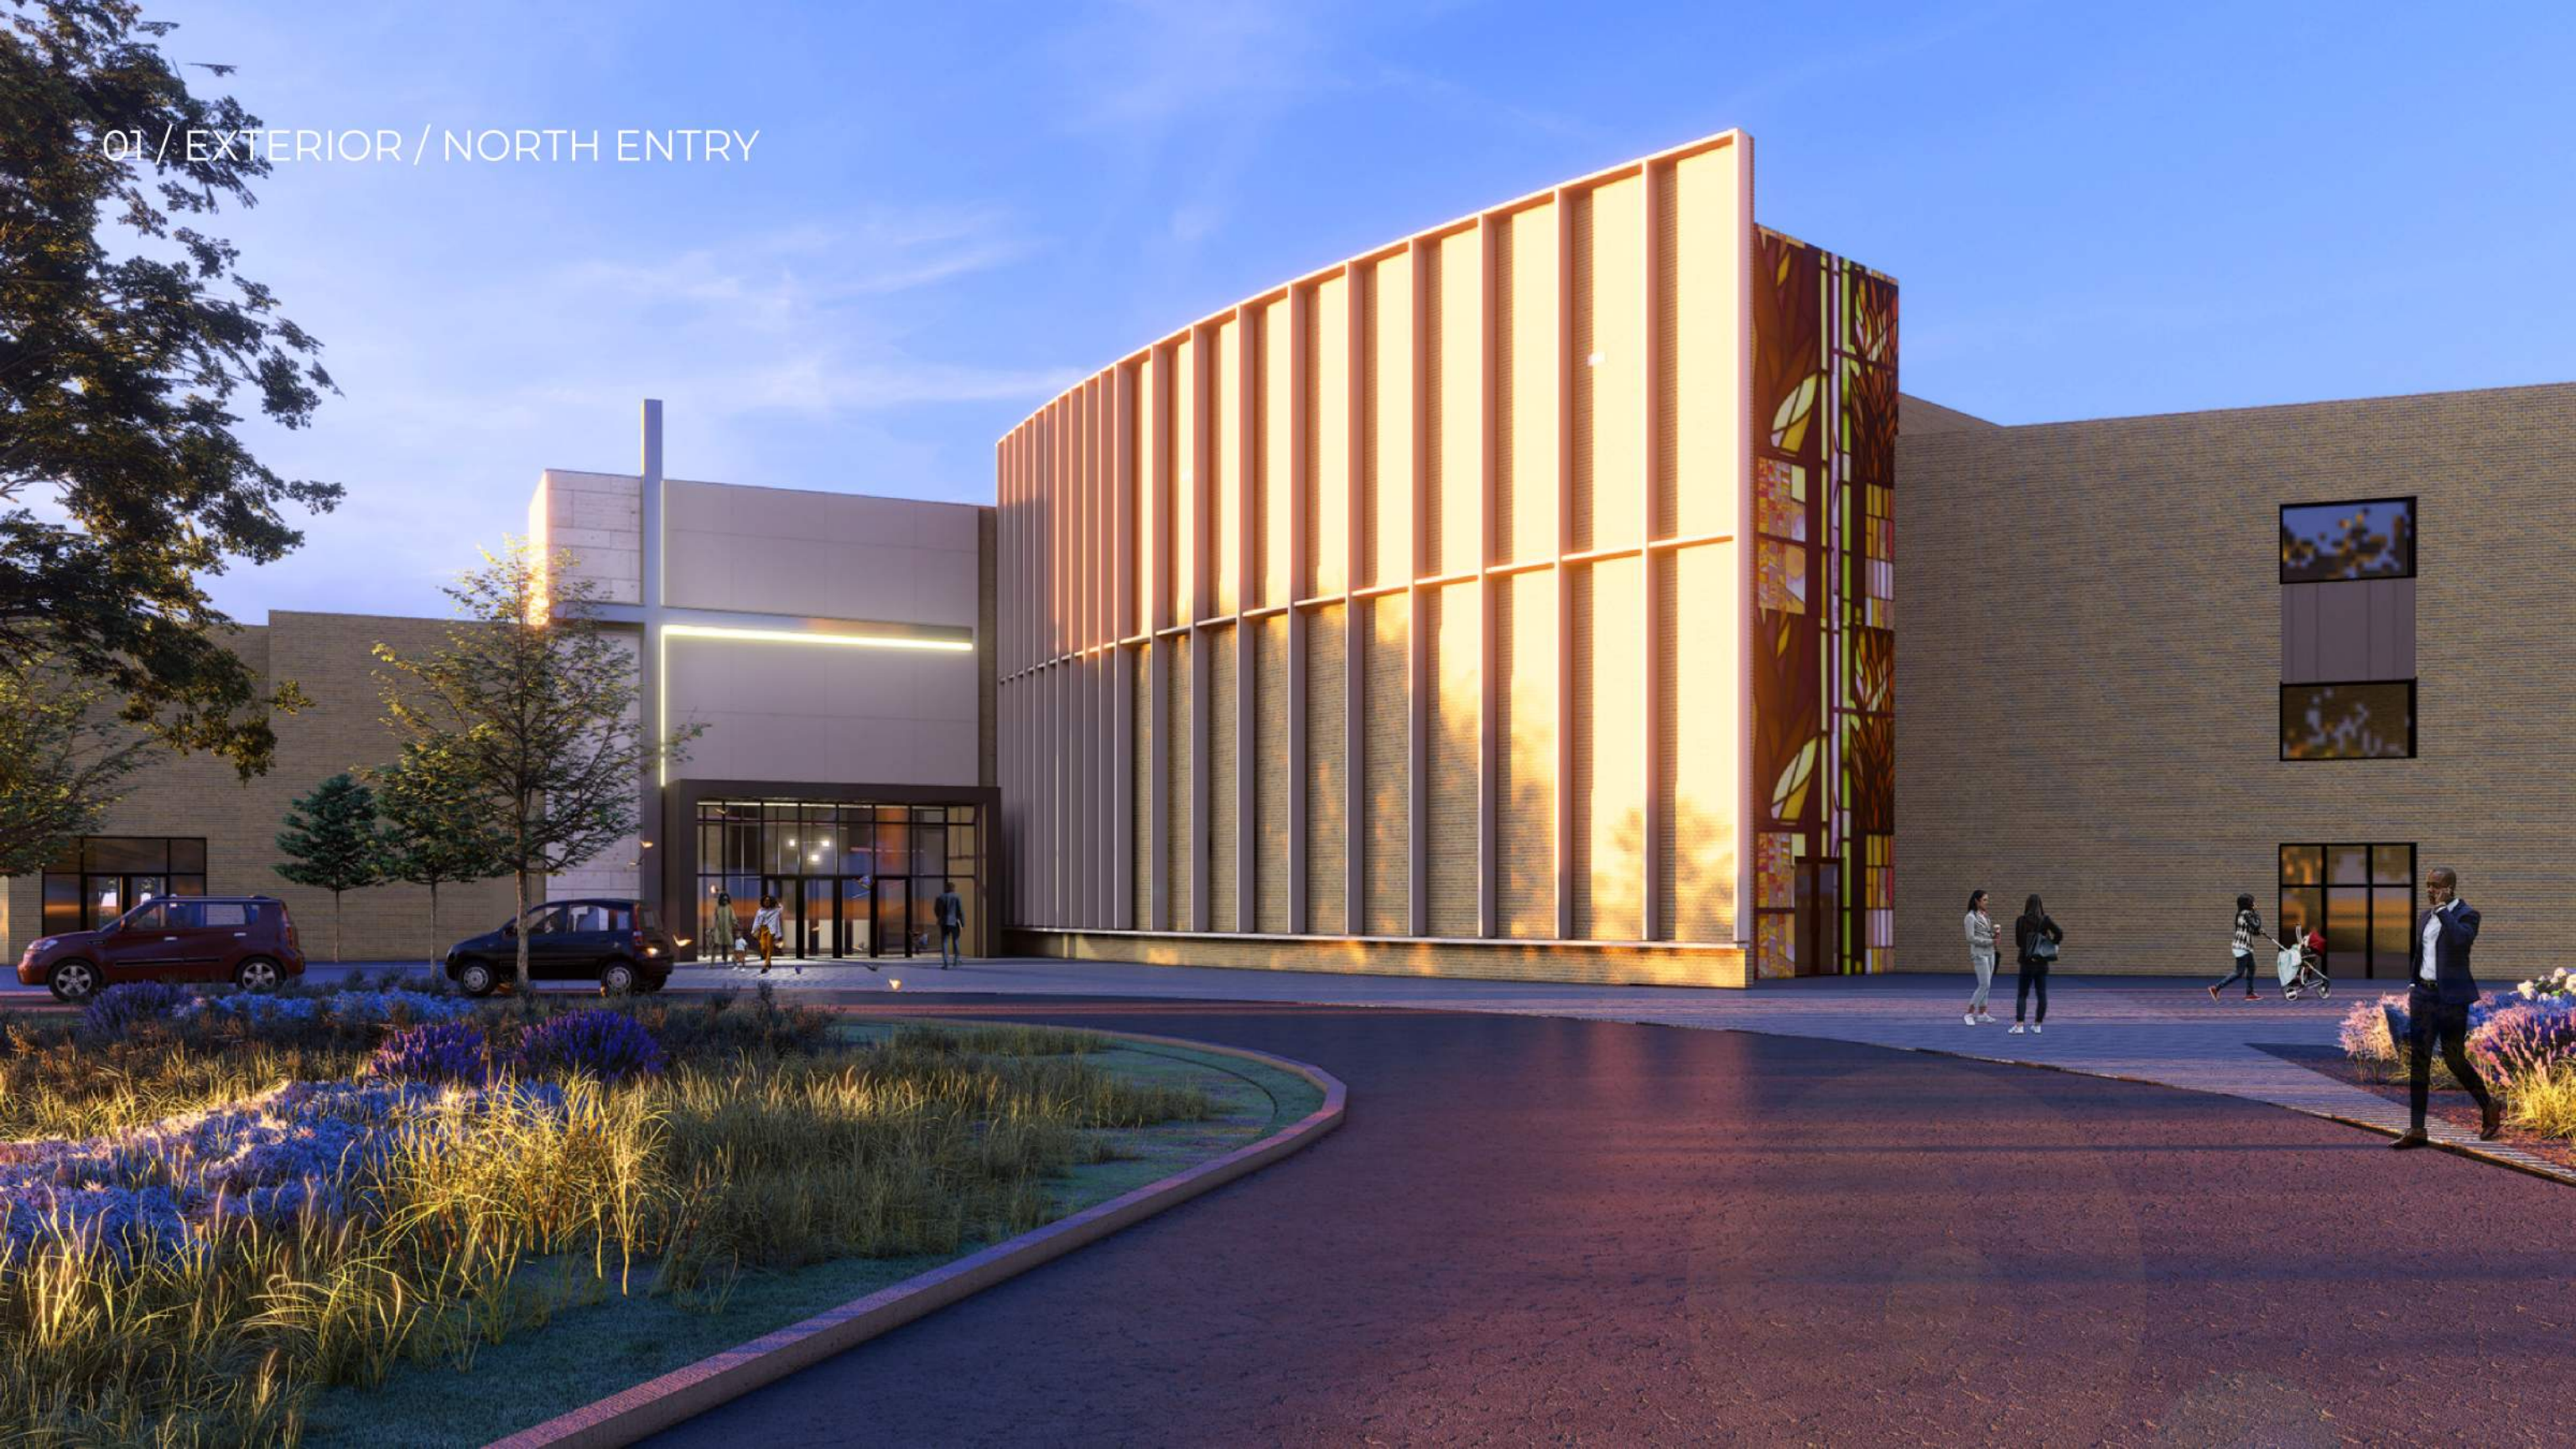
01 / EXTERIOR / EAST ENTRY

- 1** COMPOSITE METAL LOUVER SYSTEM ON EXISTING BRICK
- 2** PORCELAIN EXTERIOR WALL TILE RAINSCREEN SYSTEM. MATTE FINISH
- 3** PORCELAIN EXTERIOR WALL TILE RAINSCREEN SYSTEM. POLISHED FINISH
- 4** COMPOSITE METAL PANEL CROSS.
- 5** 15'H COMPOSITE METAL PANEL VESTIBULE
- 6** EXISTING BRICK FACADE
- 7** COMPOSITE METAL PANEL AND NEW WINDOW/DOOR OPENINGS AT NURSERY FACADE
- 8** NEW WINDOW OPENINGS IN EXISTING BRICK W/ STAINED GLASS LOOK TO LIGHT GRAND FOYER

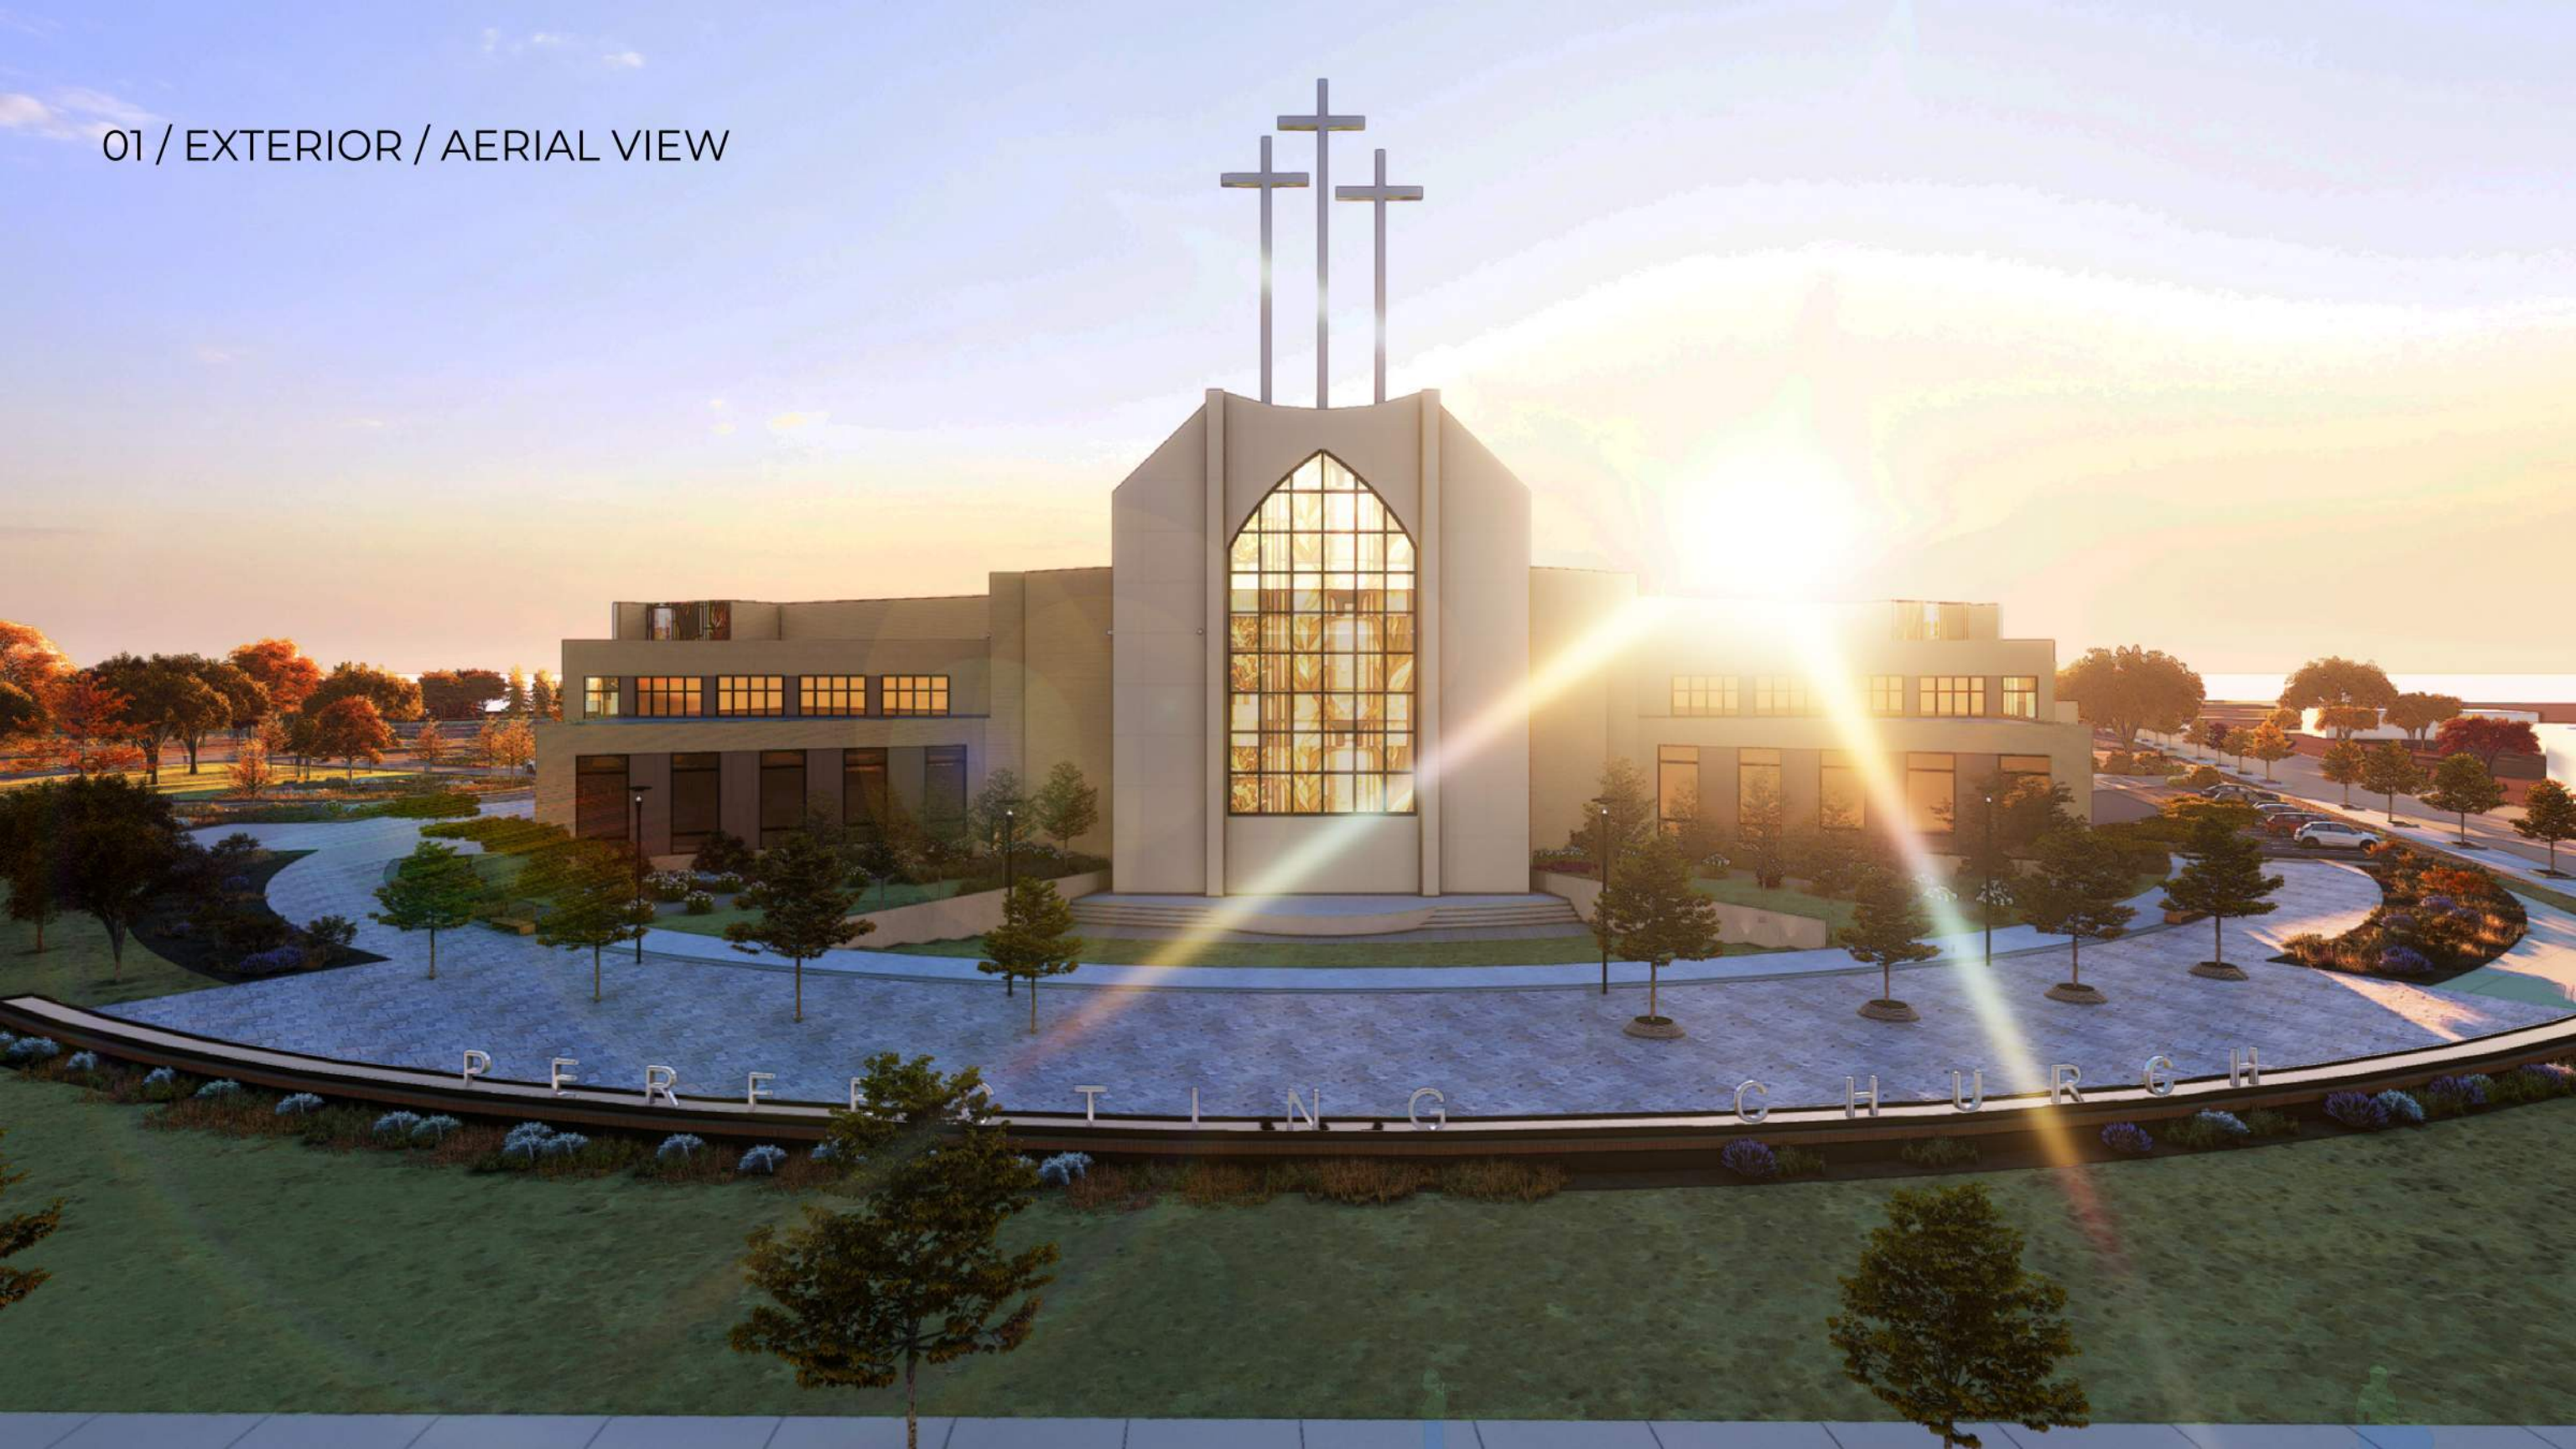
# 02 / EXTERIOR / FINISHES

- 1 TRAVERTINE-LOOK TILE RAINSCREEN SYSTEM @ MAIN ENTRIES AND FRONT FACADE
- 2 PORCELAIN EXTERIOR WALL TILE RAINSCREEN SYSTEM. MATTE FINISH
- 3 METAL LOUVERS @ MAIN ENTRIES
- 4 METAL PANEL SYSTEM @ MAIN ENTRIES, NURSERY AND AT EXISTING STOREFRONTS
- 5 DARK BRONZE STOREFRONT SYSTEM
- 6 EXISTING BRICK AND DARK BRONZE WINDOWS
